AVIATION INVESTIGATION REPORT

A01C0115

LOSS OF SEPARATION

NAV CANADA

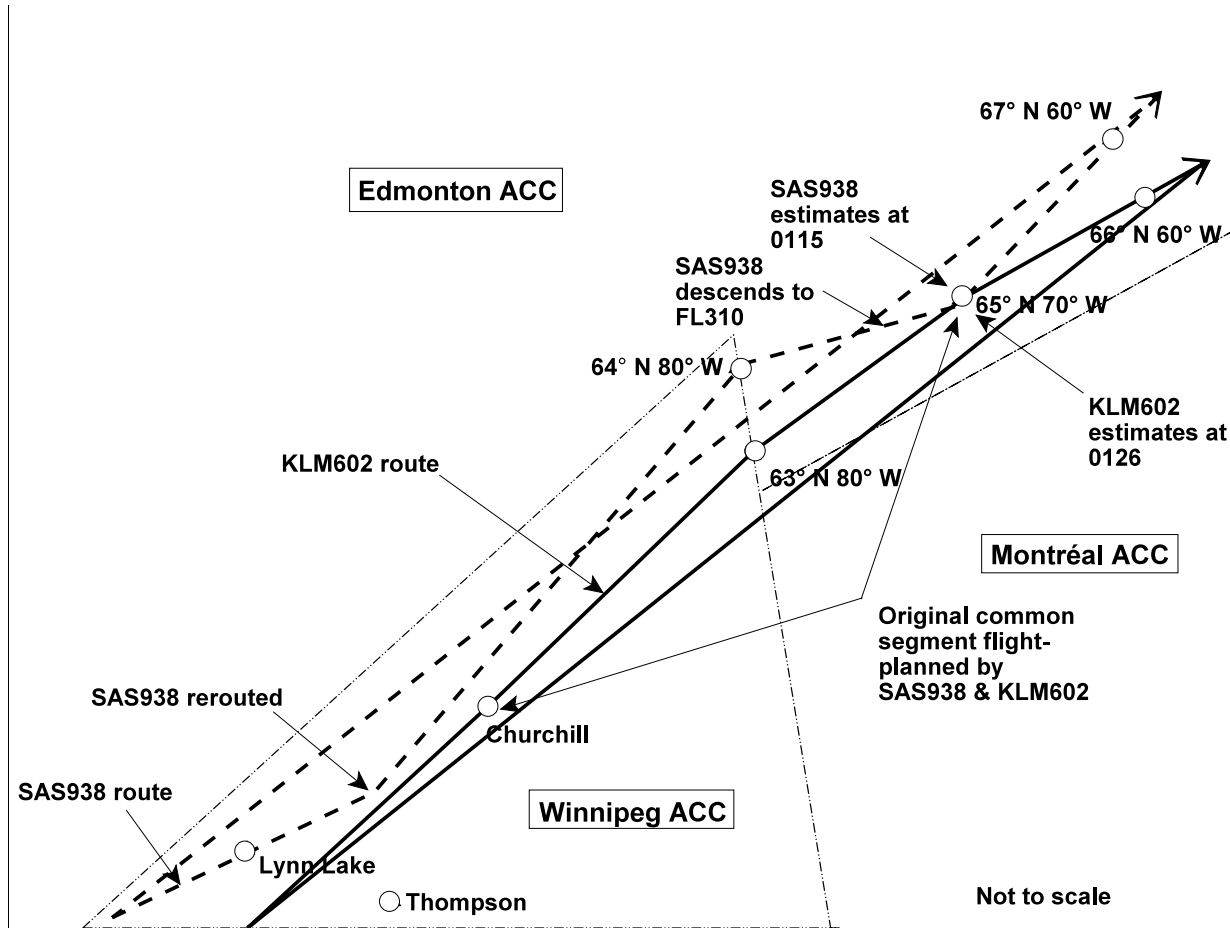
Appendix A—Aircraft Routes

During this period of intense control activity, the two controllers decided to reroute SAS938 from its flight-planned route because of a traffic conflict. This reroute was passed to SAS938 at 2319. SAS938 then followed the new clearance tracking north of Churchill (see Appendix A) to 64° north / 80° west and on to 65° north / 70° west. KLM602, which was about 13 minutes behind SAS938, remained on the flight-planned route over Churchill to 63° north / 80° west and then to 65° north / 70° west. The controller entered the change into NADS. Because both flights would enter airspace controlled by Edmonton ACC, the TL data controller contacted the NU sector controller at approximately 2330 with an SAS938 estimate. However, the TL controller did not advise the NU controller of the change in SAS938's routing, and the NU controller entered the original flight-planned route into his NSiT. The two flights then flew into NU sector at FL330 and mach .82.
